# Manhole Inspection Summary

Manhole # S67K\_\_014MH

Insp Date: **12/22/08 3:06 PM**

**Location** Address: **Kane St.**

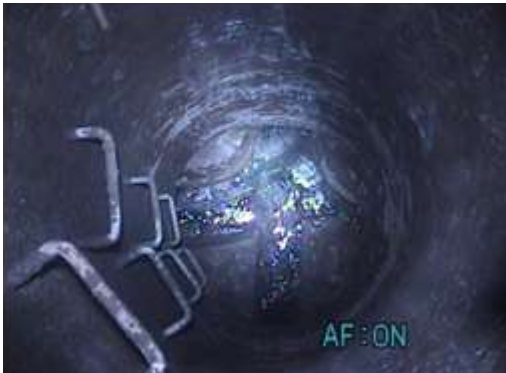
Top View

**Cover** Shape: **Circular** Diameter: **24** (in.) Length: (in.) Dist A/B Grade: **-2** (in.)

Condition: **Sound**

**Frame** Offset: **4** (in.) Condition: ☒ Sound ☐ Cracked ☐ Leaks

**Steps** Count: **9** Missing: **0** ☒ **Corroded**

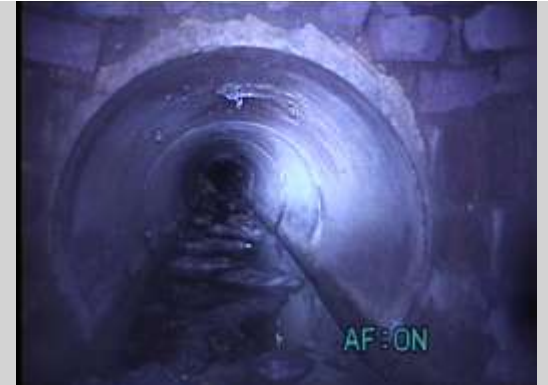
12 O'Clock Outflow

18 in. Circular Gravity Sewer  
Pipe Out @ 12 O'Clock

Pipe Height: **20.4** (in.) Rod and Bar (Angled)  
Pipe Material: **Clay** ☐ Pipe Lined  
Invert Depth: **15.92** (ft.) Flow Characteristics: **Slow**  
Deposits: ☐ None ☐ Mud ☒ **Sludge** ☐ Debris ☒ Grease  
Silt Depth: **0.5** (in.) Deposits Extent: **Light**  
Infiltration: **None** Pipe Seal Cond: **Sound**

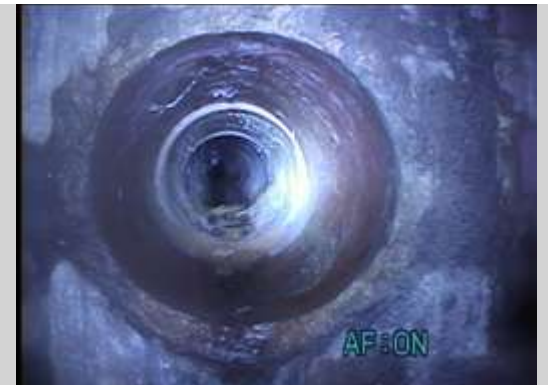
3 O'Clock Inflow

10 in. Circular Gravity Sewer  
Pipe In @ 3 O'Clock

Pipe Height: **9.6** (in.) Rod and Bar (Angled)  
Pipe Material: **Clay** ☐ Pipe Lined  
Invert Depth: **12.50** (ft.) Flow Characteristics: **Slow**  
Deposits: ☐ None ☐ Mud ☒ **Sludge** ☐ Debris ☐ Grease  
Silt Depth: **0.25** (in.) Deposits Extent: **Light**  
Infiltration: **None** Pipe Seal Cond: **Sound**

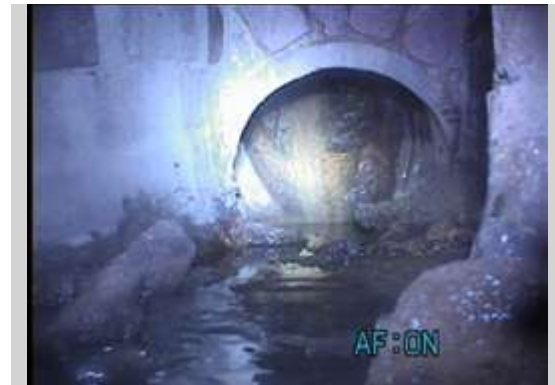
Drop In @ 3 O'Clock

Drop: **Outside** Rod and Bar  
Angled: **Yes** Reading: **14.83** (ft.)  
Inv Depth: **15.83** (ft.)  
Drop Condition: **Open**

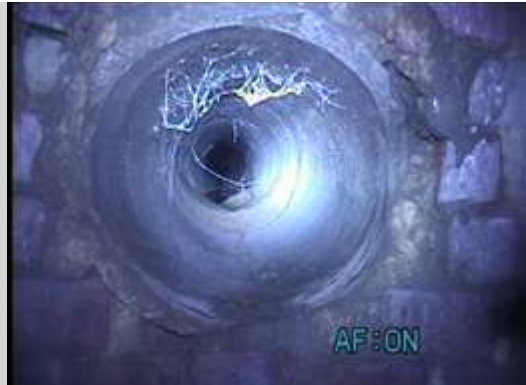
6 O'Clock Inflow

Pipe In @ 6 O'Clock

Pipe Height: **9.6** (in.) Rod and Bar (Angled)

Deposits: ☐ None ☐ Mud ☒ Sludge ☒ Debris ☐ Grease

Silt Depth: **0.5** (in.) Deposits Extent: **Medium**

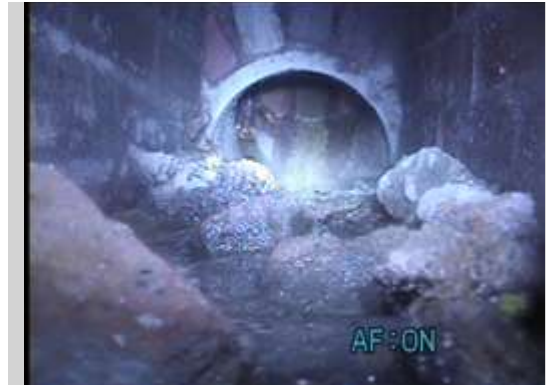
Drop In @ 6 O'Clock

Drop: **Outside** Rod and Bar  
Angled: **Yes** Reading: **14.83** (ft.)  
Inv Depth: **15.83** (ft.)

Drop Condition: **Open**

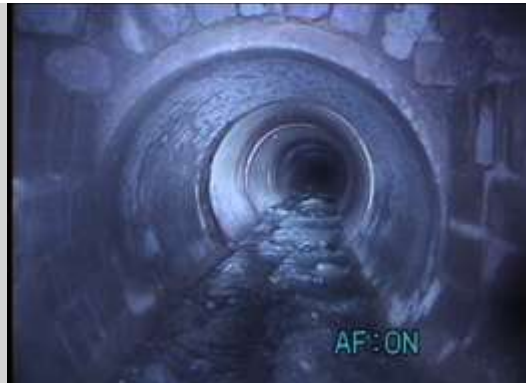
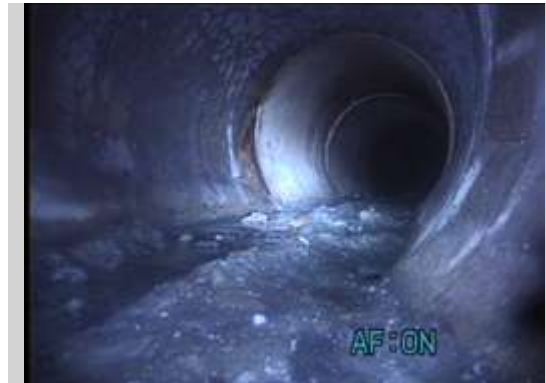
9 O'Clock Inflow

Pipe In @ 9 O'Clock

Pipe Height: **18** (in.) Rod and Bar (Angled)

Invert Depth: **15.67** (ft.) Flow Characteristics: **Fast**

Deposits: ☒ None ☐ Mud ☐ Sludge ☐ Debris ☐ Grease
